# Inspection Report

**Barney Rubble**  
**345 Stone Cave Rd**  
**Bedrock , OH 44000**

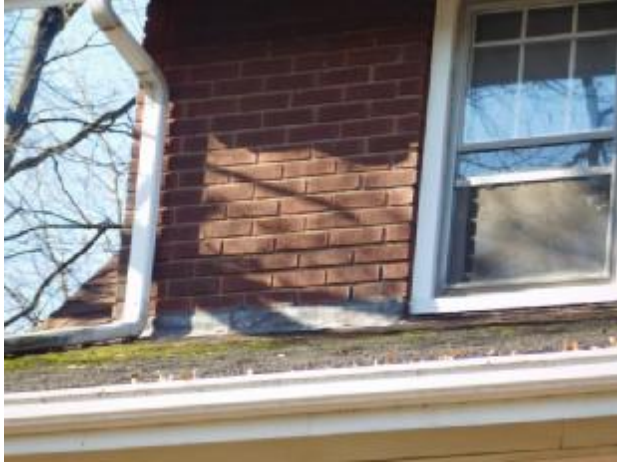
**#R1**

1. There is a fungus growing on the shingles. This will allow for premature aging of the shingles. Recommend a reputable contractor. (see photo 1).
2. Rear right down spout improperly draining. This will allow for water infiltration to foundation. Recommend a reputable contractor. (see photo 2).

**Fungus Growing**

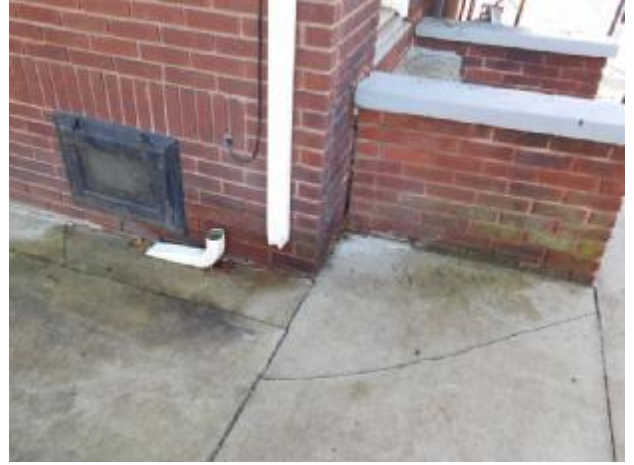
**#R2**

**Improper Drainage**

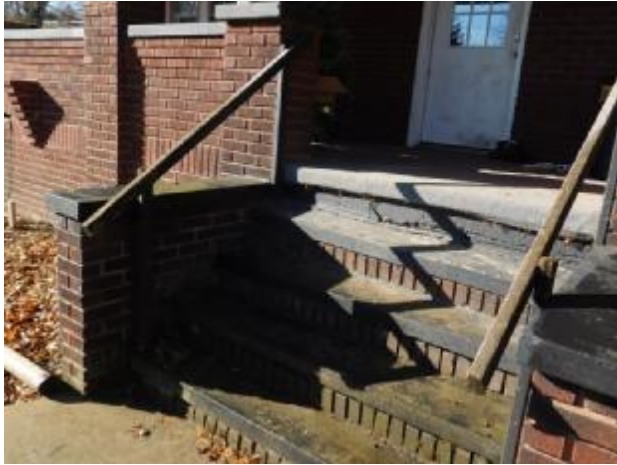
**#EX1**

**No Handrail at front entrance**

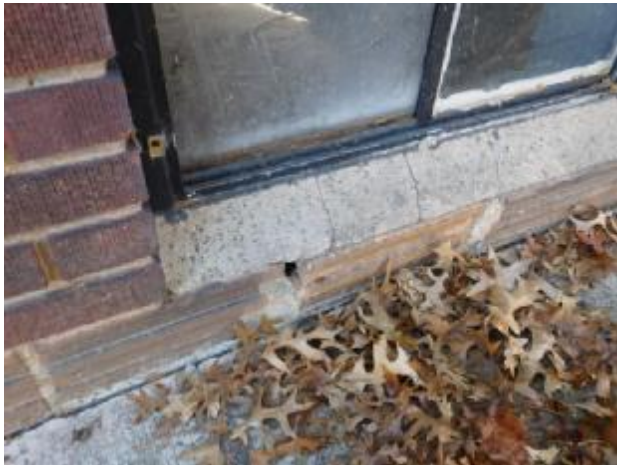
**#EX3**

**Missing mortar**

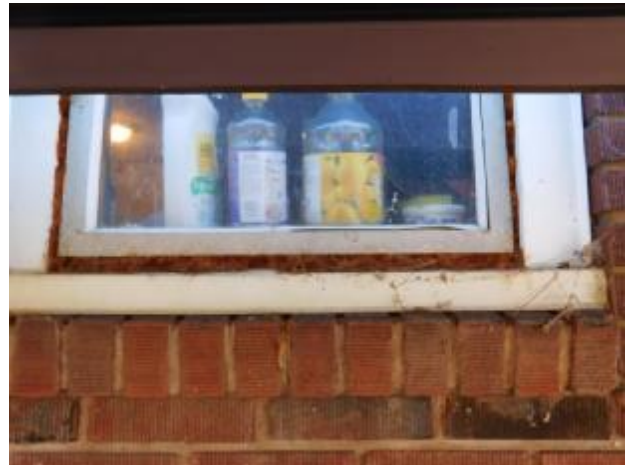
**#EX4**

**Window does not operate/foam**

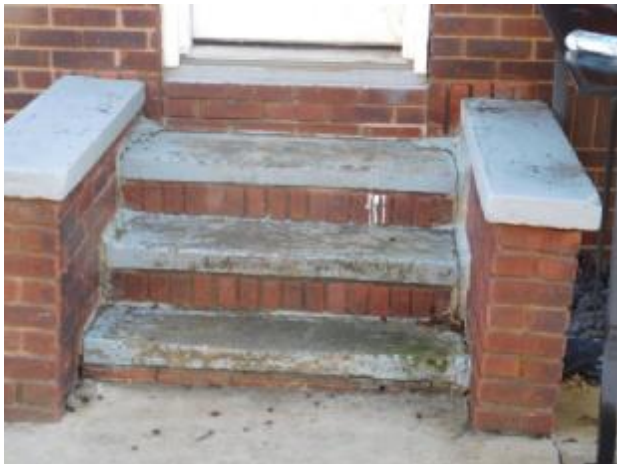
**#EX5**

**No handrail at back entrance**

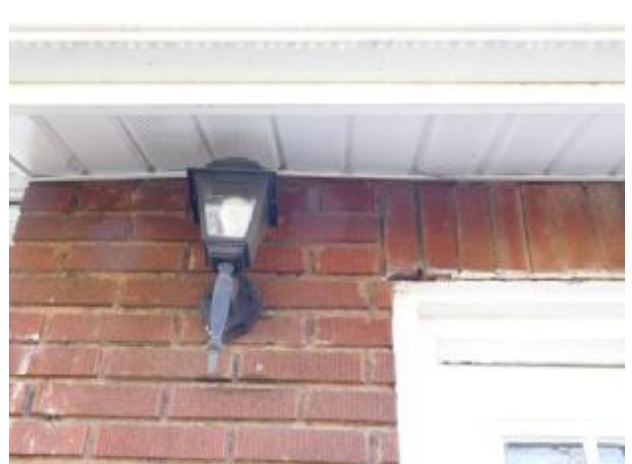
**#EX6**

**Light not working/missing caulking**

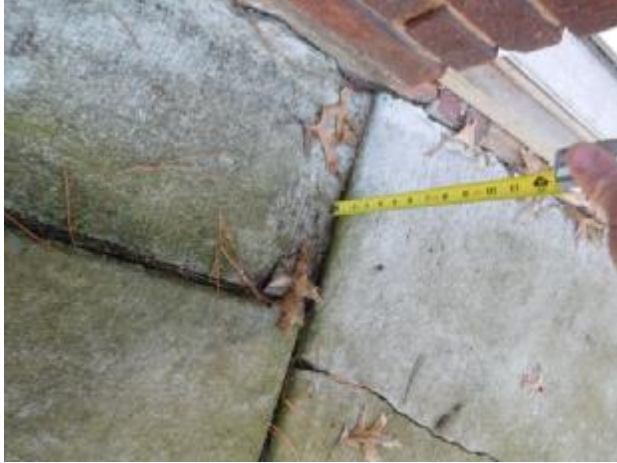
**#GD1**

- SAFETY HAZARD.** Uneven pavement along right side of house. Recommend a reputable contractor. (see photo 1).
- Ruts in driveway, recommend adding gravel. (see photo 2).
- SAFETY HAZARD.** Trip hazard where driveway meets walkway. Recommend adding gravel to drive. (see photo 3).
- SAFETY HAZARD.** Trip hazard at front sidewalk, where yard does not meet walkway. Recommend adding topsoil to yard. (see photo 4).

**Uneven sidewalk**

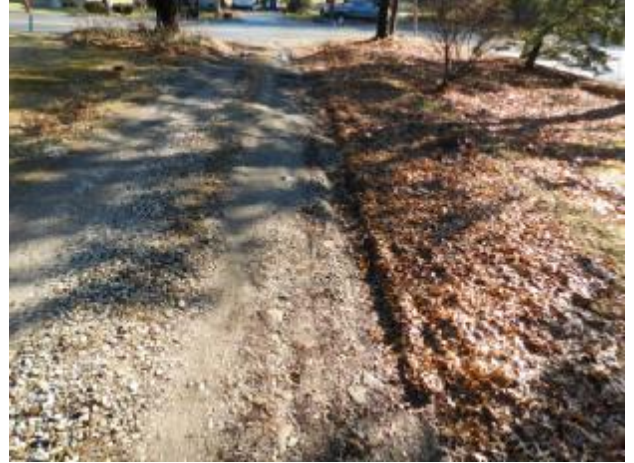
**#GD2**

**Ruts in driveway**

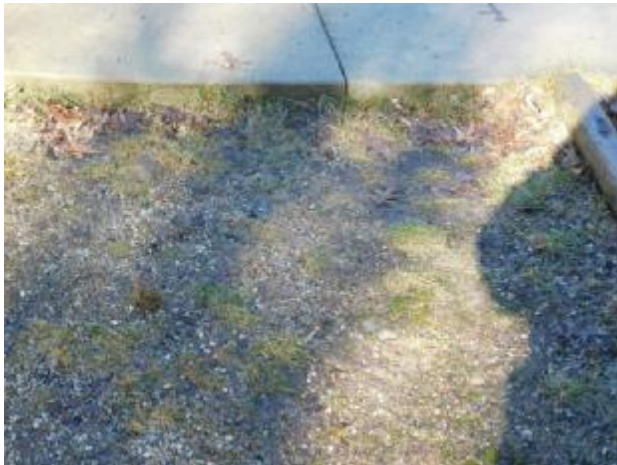
**#GD3**

**Uneven ground at driveway**

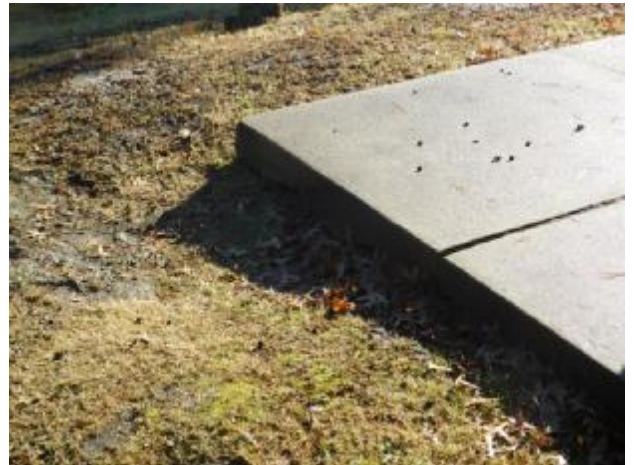
**#GD4**

**Uneven ground front walkway**

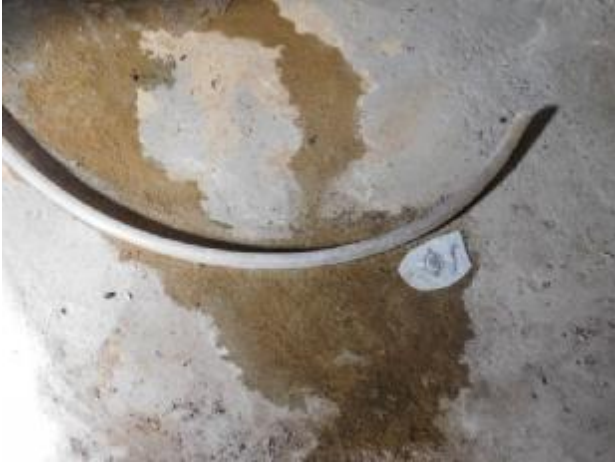
**#HC1**

1. Unable to evaluate air conditioning system due to outdoor ambient air temperature being below degrees. Operating below this temperature can damage air conditioning compressor.
2. Improper drain routing for AC coil. This will allow for water to leak on floor and cause for a slip hazard, possible mold growth. Recommend a reputable licensed HVAC contractor. (see photo 1).

**Improper AC drainage**

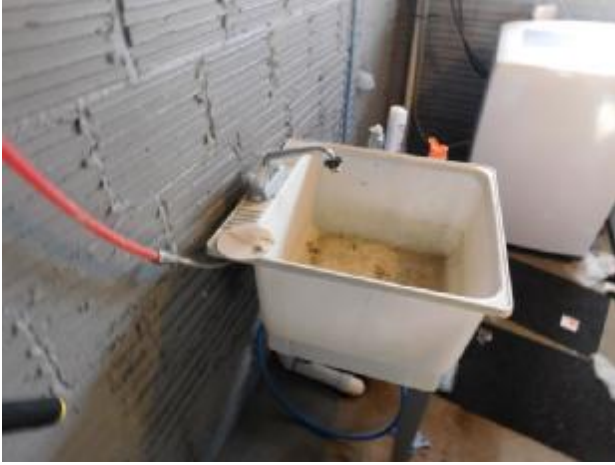
**#P1**

1. Utility sink not attached to wall. Improperly attached supply line. Recommend a reputable licensed plumbing contractor. (see photo 1).

**Not mounted/ improper supply line**

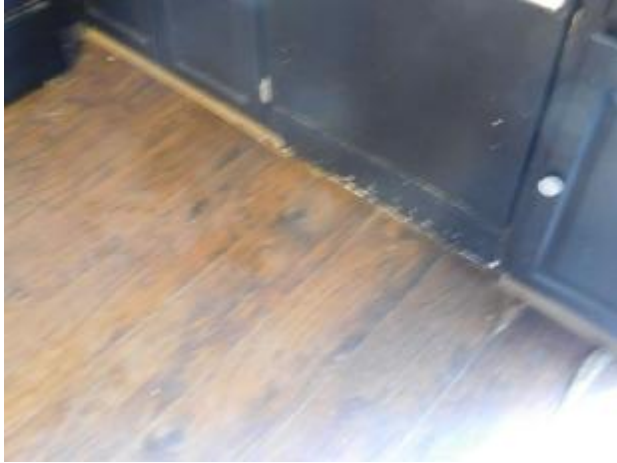
**#K1**

1. **SAFETY HAZARD**. Dish washer is leaking. This could cause a slip hazard and also cause the floor to buckle. Recommend a reputable licensed plumbing contractor. (see photo 1).

**Leaking dishwasher**

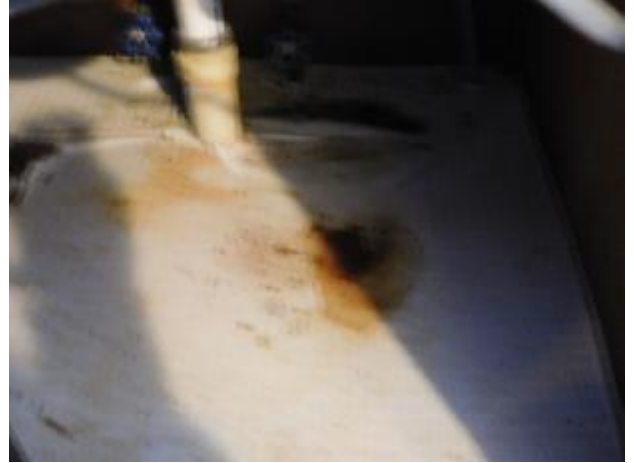
**#K2**

2. Evidence of prior leak under kitchen sink. Continue to monitor. (see photo 2).

**Signs of previous leak**

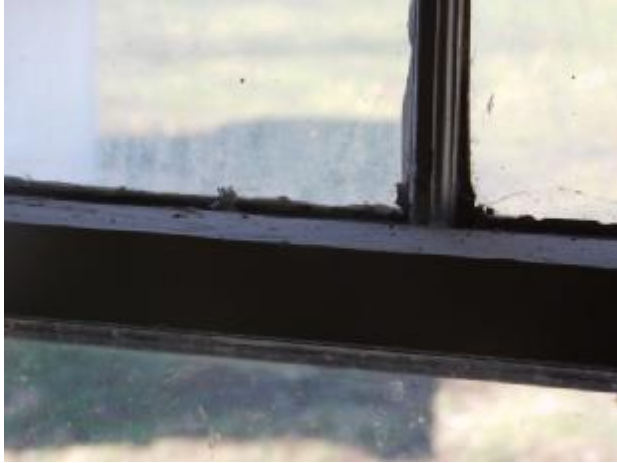
**Bathroom #B1**

1. **SAFETY HAZARD**. Missing window lock. Recommend installing lock. (see photo 1).

**Non-locking window**

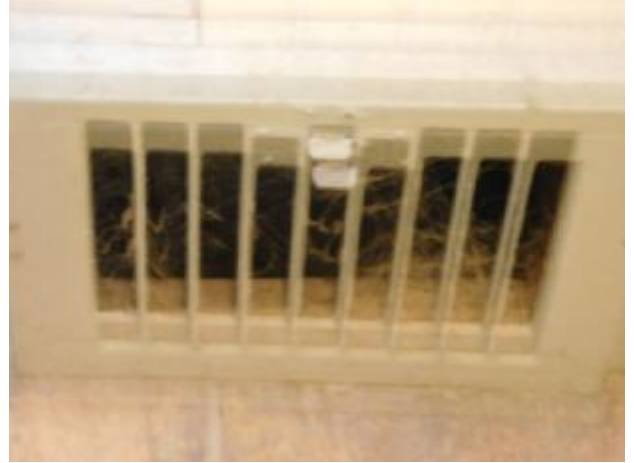
**Bathroom #B2**

**Non-working bathroom vent**

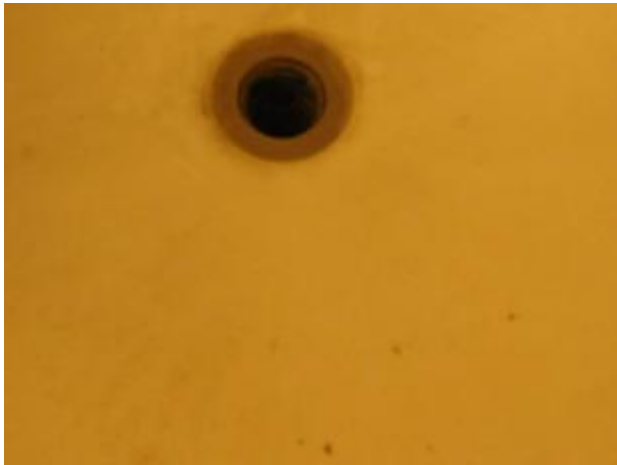
**Bathroom #B3**

2. Missing sink stop. Recommend installing sink stop. (see photo 2).

**No stopper in sink**

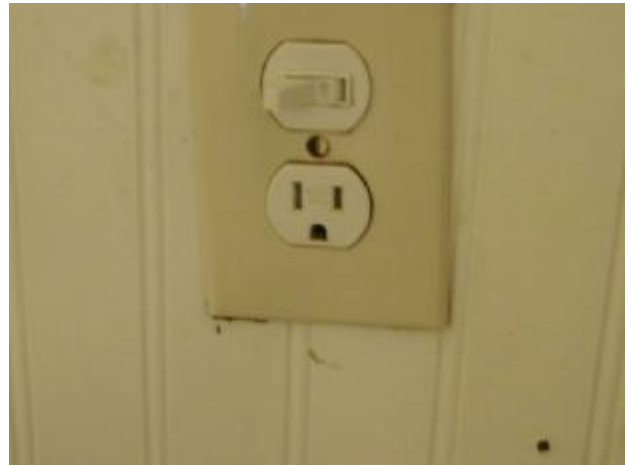
**Bathroom #B4**

3. **SAFETY HAZARD**. No GFCI at bathroom sink. This will allow for a shock or worse. Recommend a reputable licensed electrical contractor. (see photo 4).

**No GFCI**

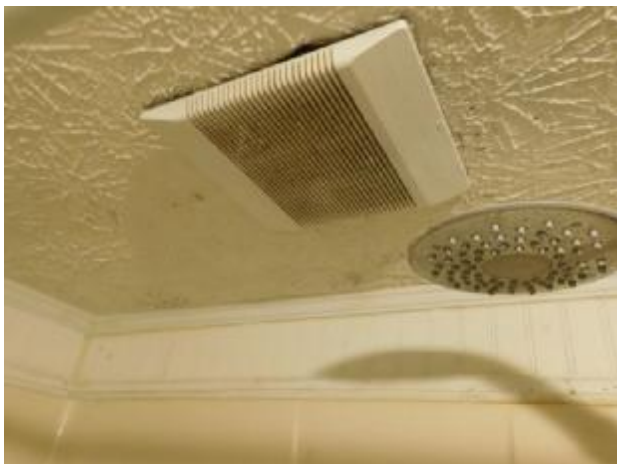
**Bathroom #B5**

4. Bath exhaust fan not working and possible mold. Recommend a reputable licensed electrical contractor. (see photo 5)

**Non-working exhaust vent**

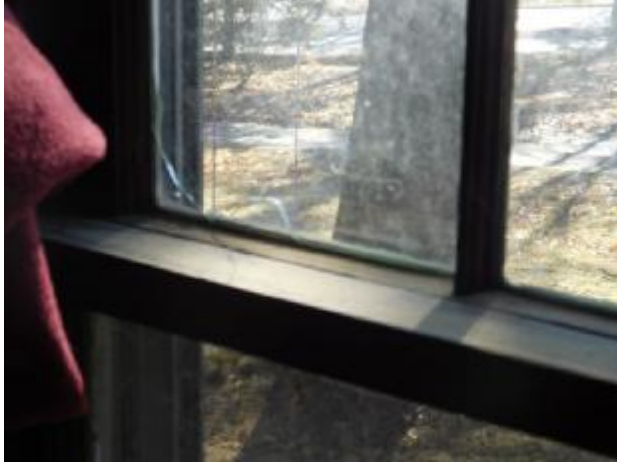
**#IR1**

1. **SAFETY HAZARD**. Cracked window pane in dining room. Recommend a reputable contractor. (see photo 1).

**Cracked glass in dining room**

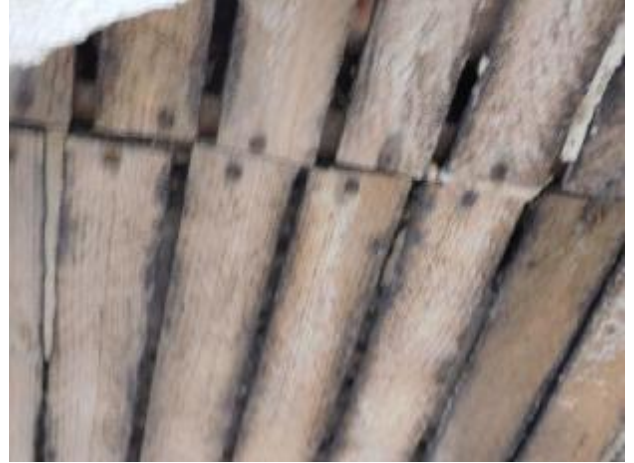
**#IR2**

2. Missing plaster on back bedroom ceiling. Possible mold. Recommend a reputable contractor. (see photo 3).

**Falling ceiling in back bedroom**

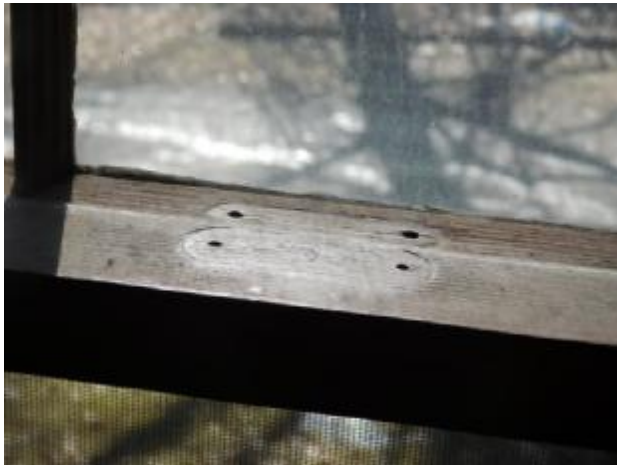
**#IR3**

3. **SAFETY HAZARD**. Missing window lock on back bedroom window. Recommend installing lock. (see photo 3).

**Missing lock back bedroom window**

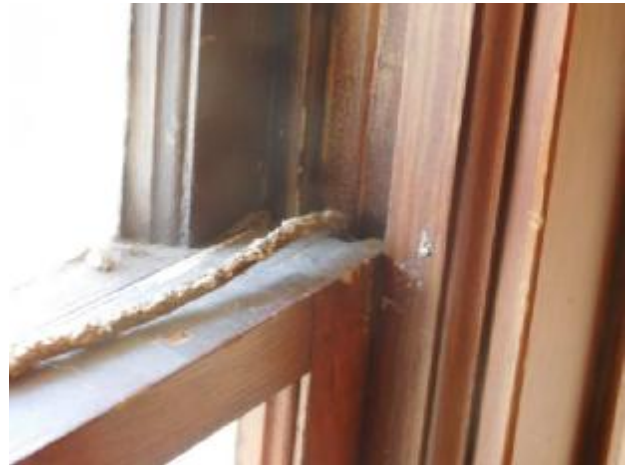
**#IR4**

4. **SAFETY HAZARD**. Broken sash cord in back bedroom rear window. Recommend a reputable contractor. (see photo 4).

**Broken sash cord back bedroom**

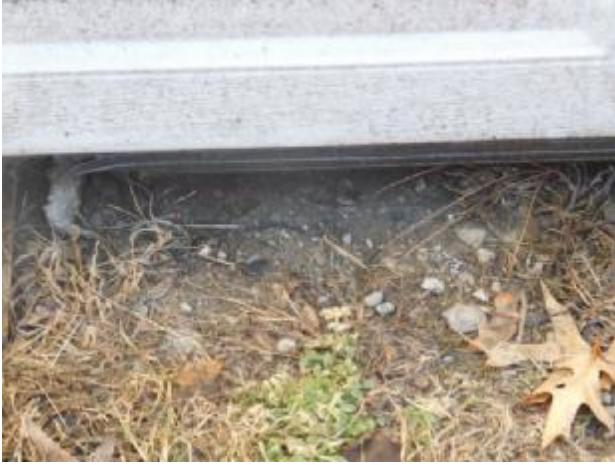
**#GC1**

1. Door does not meet ground. This will allow for water and pest infestation. Recommend adding gravel to drive to make them meet. (see photo 1).

**Gap at garage door**

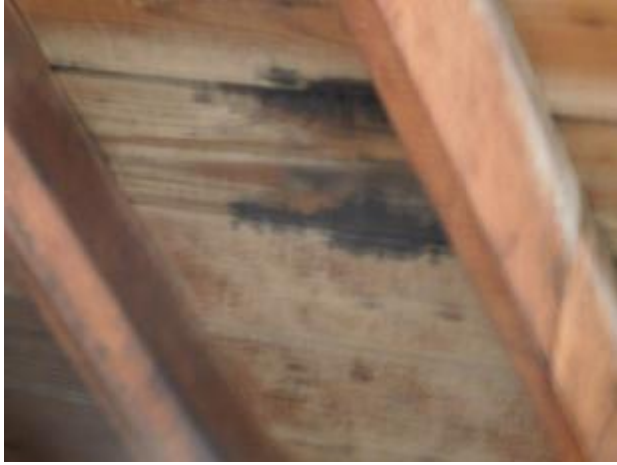
**#AT1**

1. Signs of water leak. As of today's inspection was dry. Continue to monitor. (see photo 1).

2. Signs of possible mold growth. Recommend a reputable licensed EPA contractor. (see photo 1).

**Possible mold**

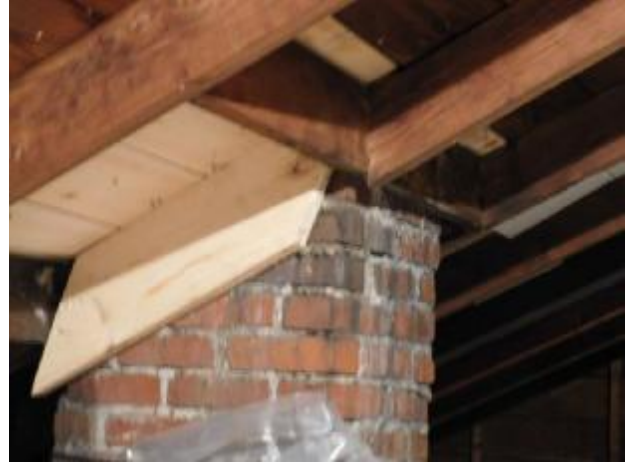
**#AT2**

3. Signs of prior repair. Repair shows poor workmanship. Recommend a reputable contractor. Continue to monitor (see photo 2).

**Poor workmanship**

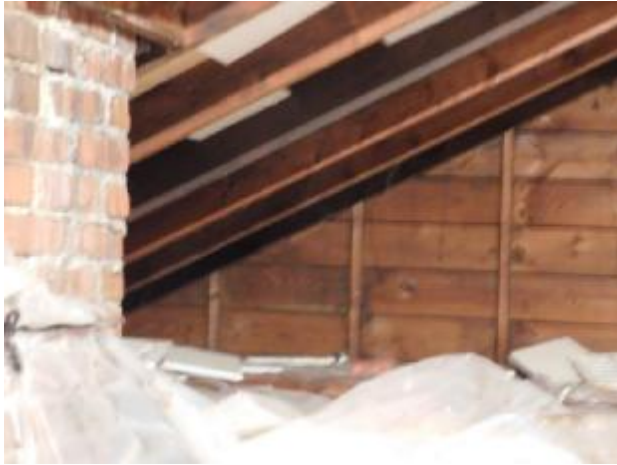
**#AT3**

4. Missing vent line for bathroom exhaust fan. The vent must be either through the roof or soffit. This will allow for moisture and mold in the attic. Recommend having one added. Recommend a reputable contractor. (see photo 3).

**No bathroom vent connection**

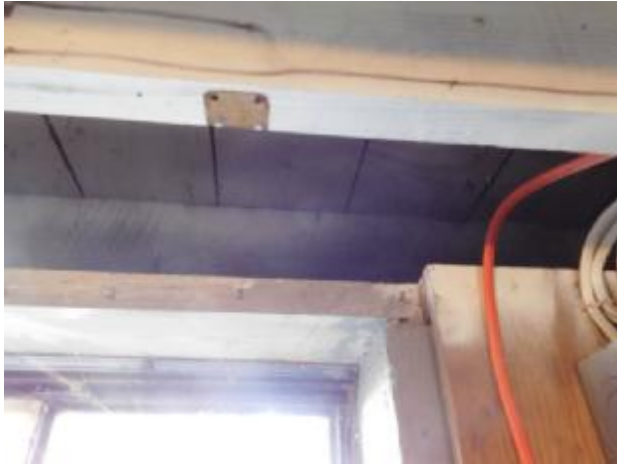
**Foundation #F1**

1. No insulation at sill plate in basement. Recommend installing insulation to help keep heat in and cold out. Recommend a reputable contractor. (see photo 1).

**Missing insulation**

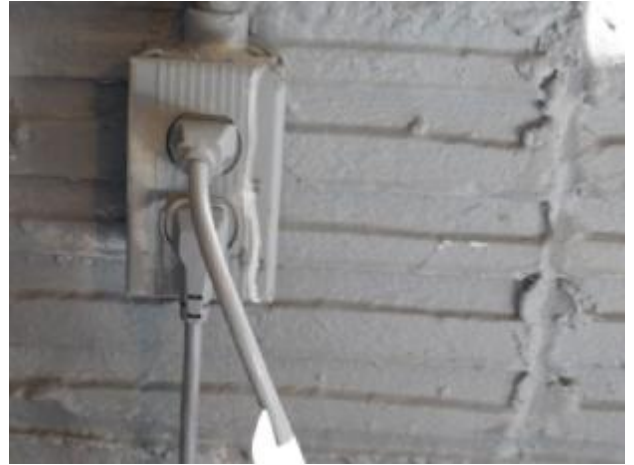
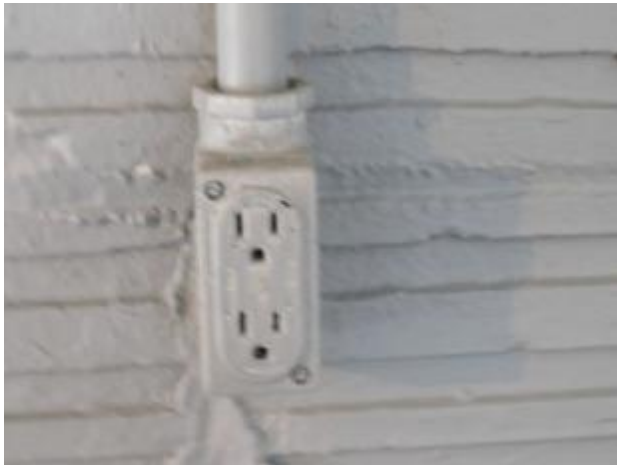
**Foundation #F2**

2 **SAFETY HAZARD**. No GFCI's in basement. This will allow for a shock or worse. Recommend a reputable licensed electrical contractor. (see photos 2 & 3).

**No GFCI**
